2025 DENNISTON AND SAN VICENTE WATERSHED SANITARY SURVEY

Prepared for Coastside County
Water District

Half Moon Bay, CA

September 2025

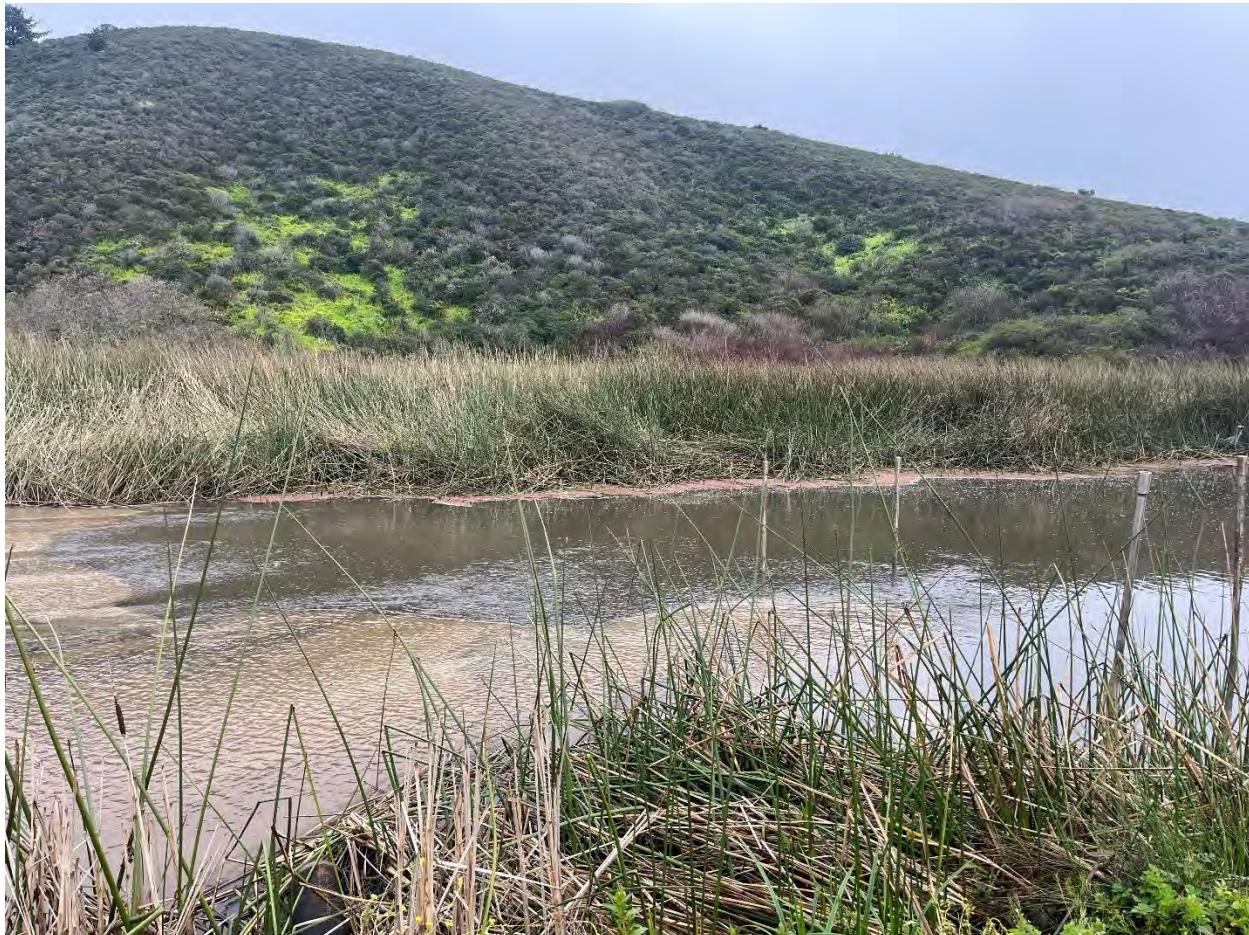
Photo 1: Denniston reservoir, facing east. Large amounts of sediment in the reservoir.

In the past, the District has instituted vegetation management including pond dredging as needed to reduce sedimentation at the Denniston Reservoir intake. The dredging is an annual maintenance activity conducted to prevent sedimentation at the pump station intake. The dredging permit can be found in Appendix D.

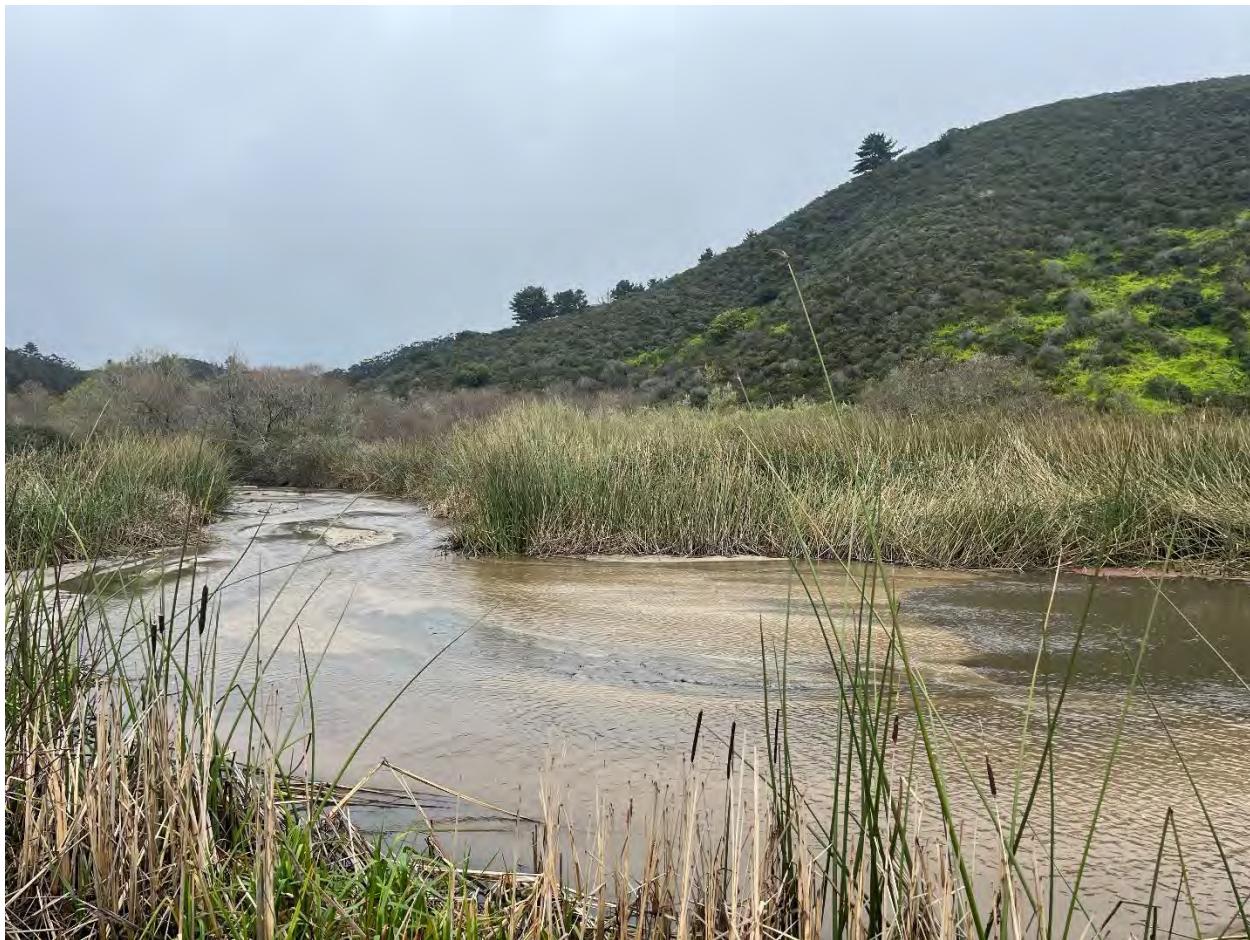
Photo 2. Denniston Creek diversion, flowing into the Denniston reservoir. Photo facing north towards Denniston Creek.

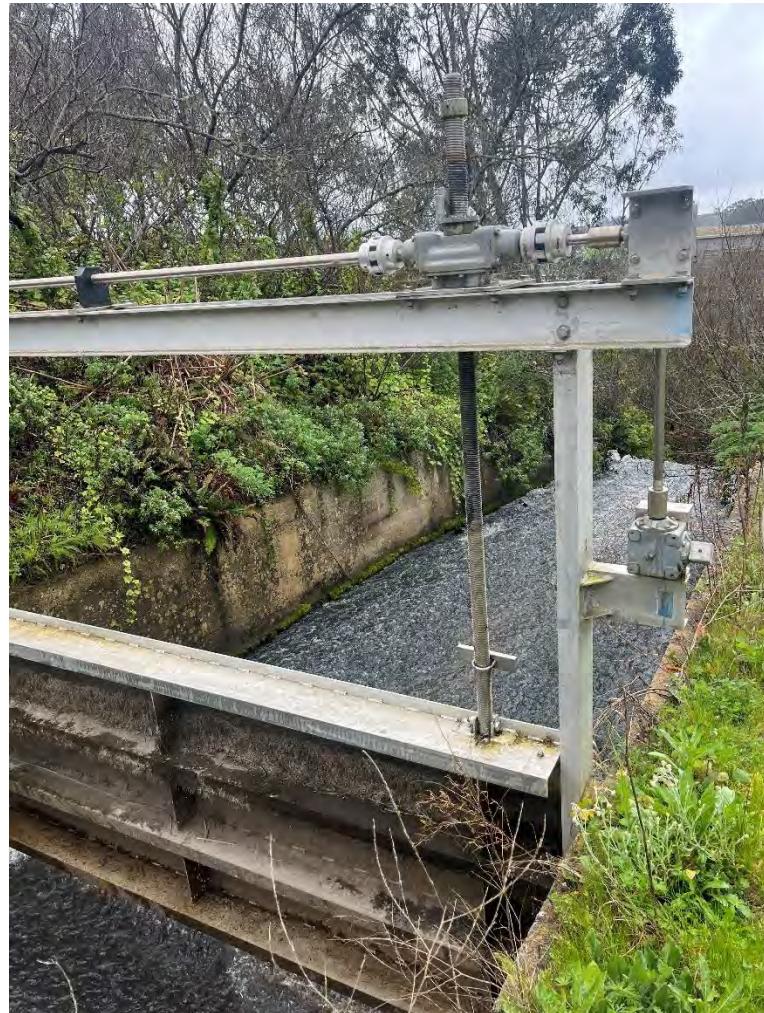
Photo 3: Denniston reservoir outfall.

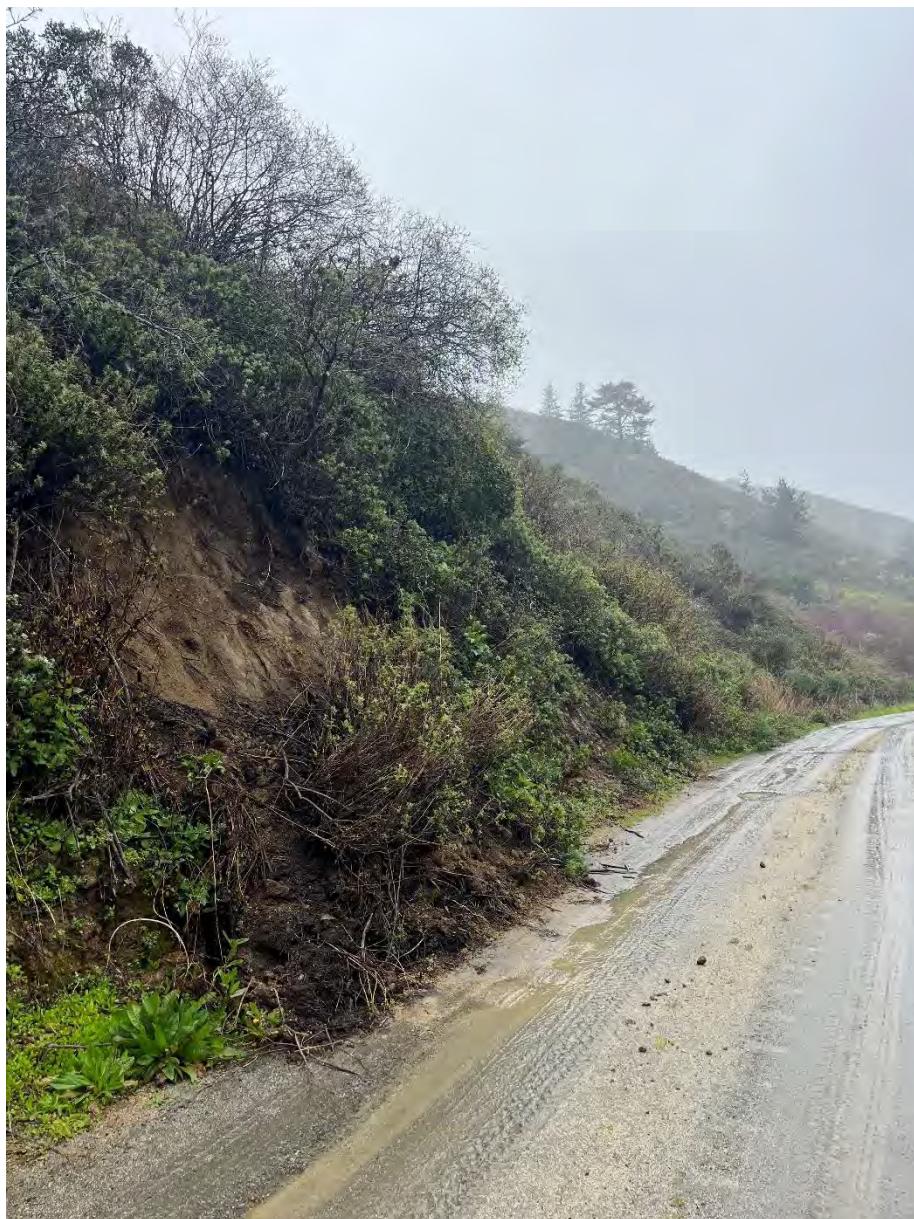
Photo 5: Slight erosion along the unnamed road past the Denniston WTP.

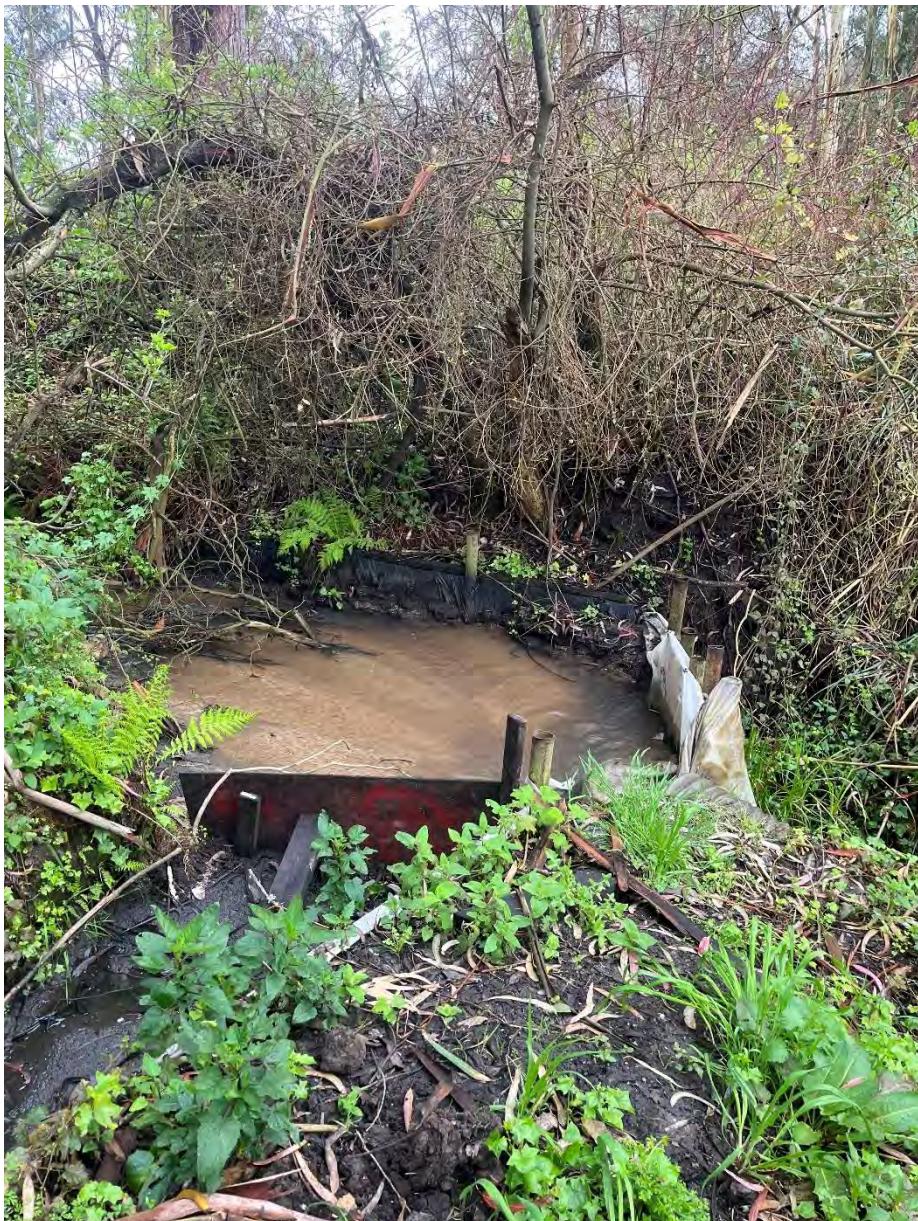
Photo 6: San Vicente Creek Diversion located off of Ranch Road past Moss Beach ranch.

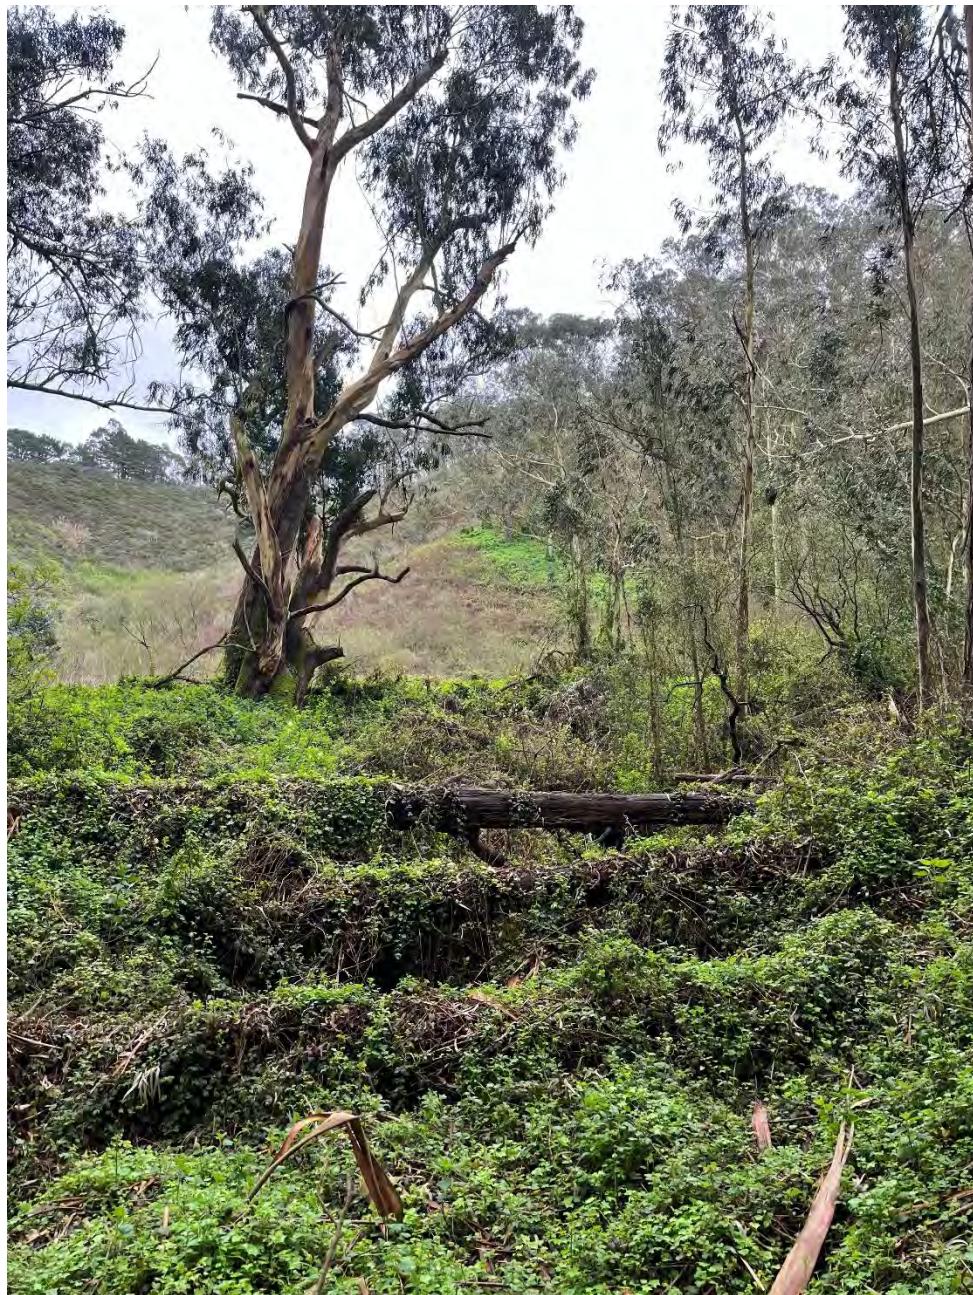
Photo 7: Upper San Vicente Creek Watershed, taken above the San Vicente Creek Diversion. As shown here, the San Vicente watershed is largely undeveloped and unimpacted by human activity.

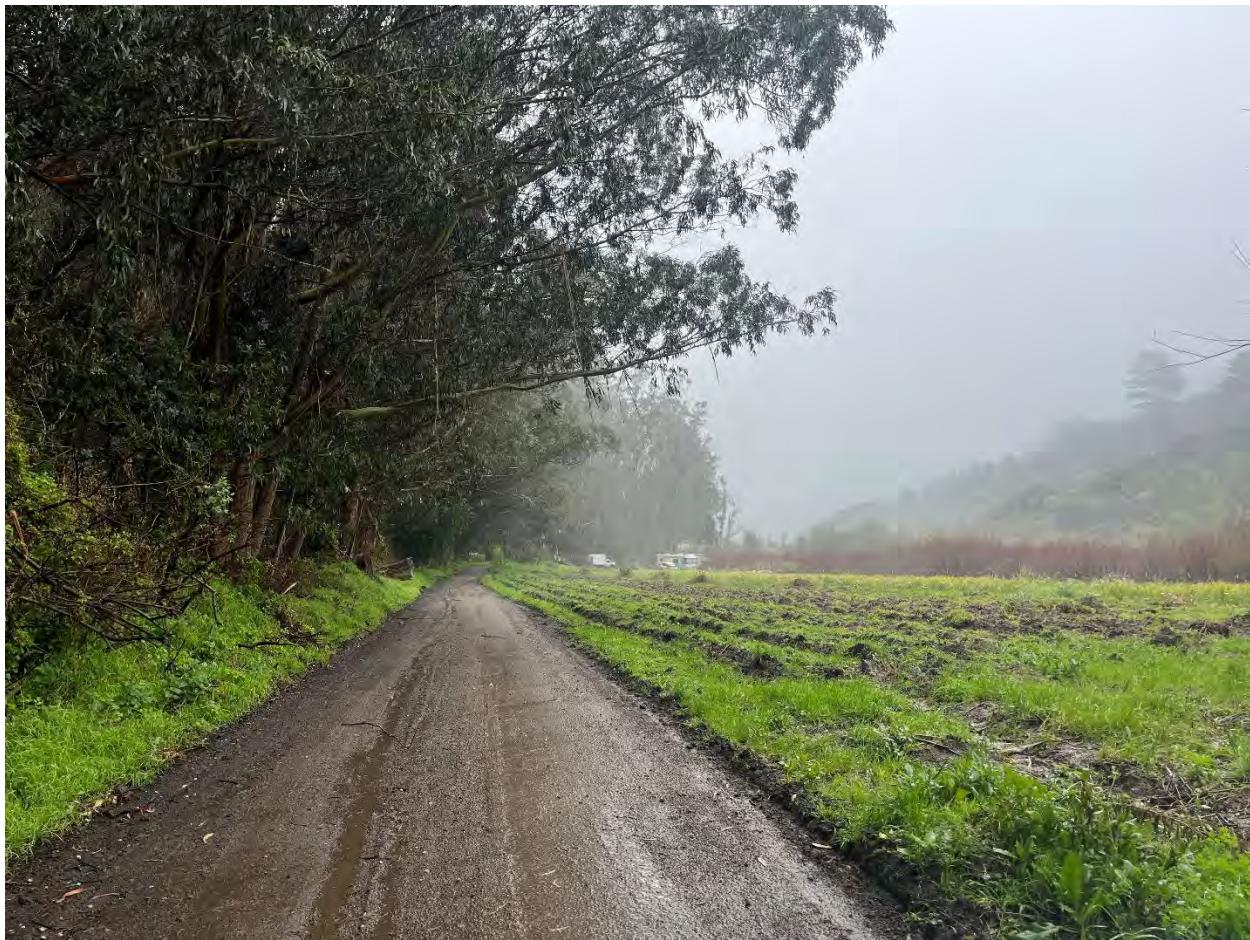
Photo 8: Floriculture farms in the San Vicente watershed, accessed via Christine Road.

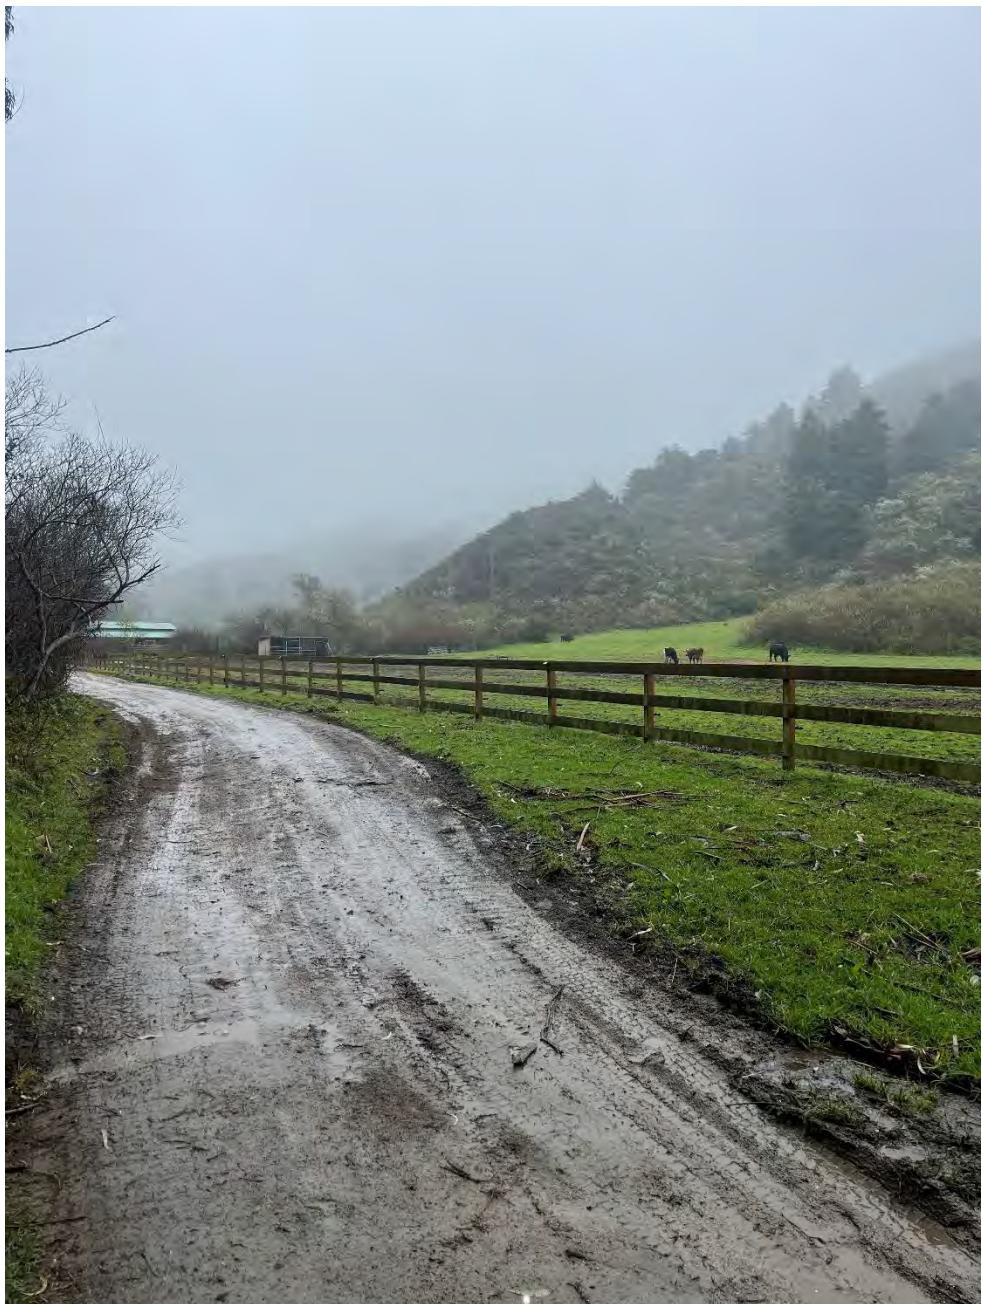
Photo 10: A pasture with cows along Christine Road in the San Vicente watershed. There appears to be small amounts of livestock including a few horses and cows in the parcel owned by the Anelle Family.

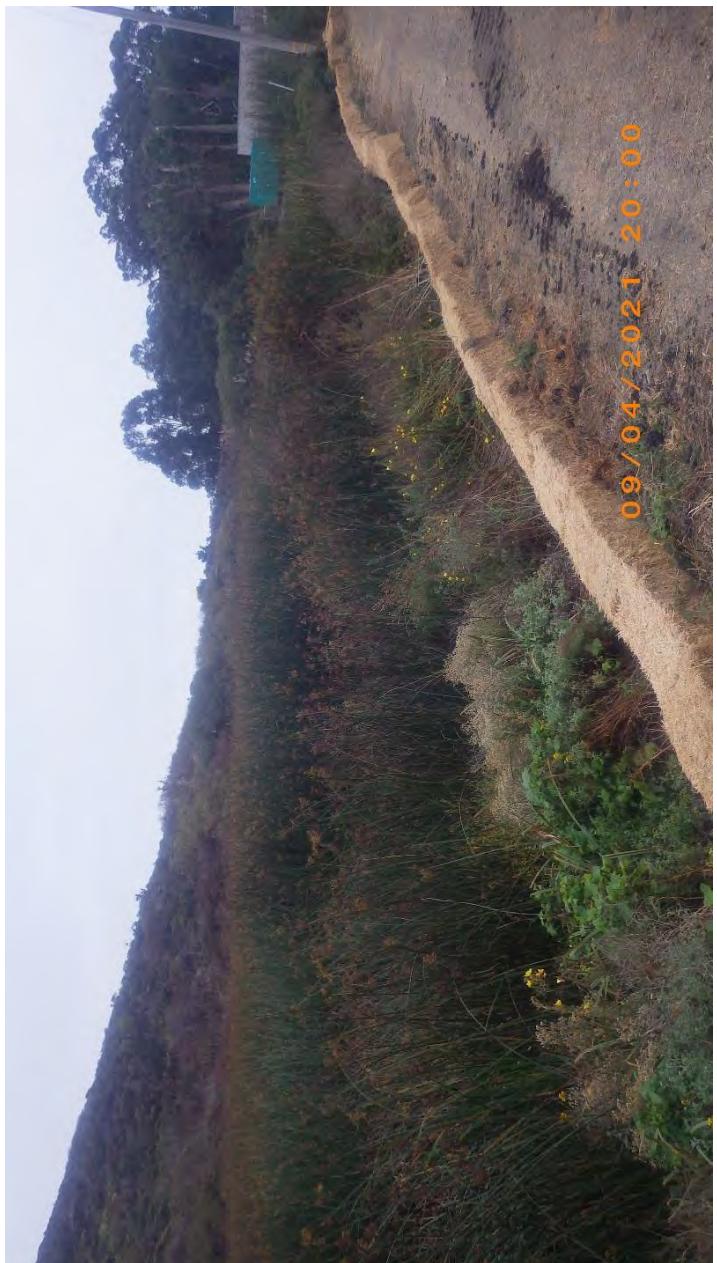
Straw bales are placed along N. edge of operations. Note large tules across waterway. 10/04/2021

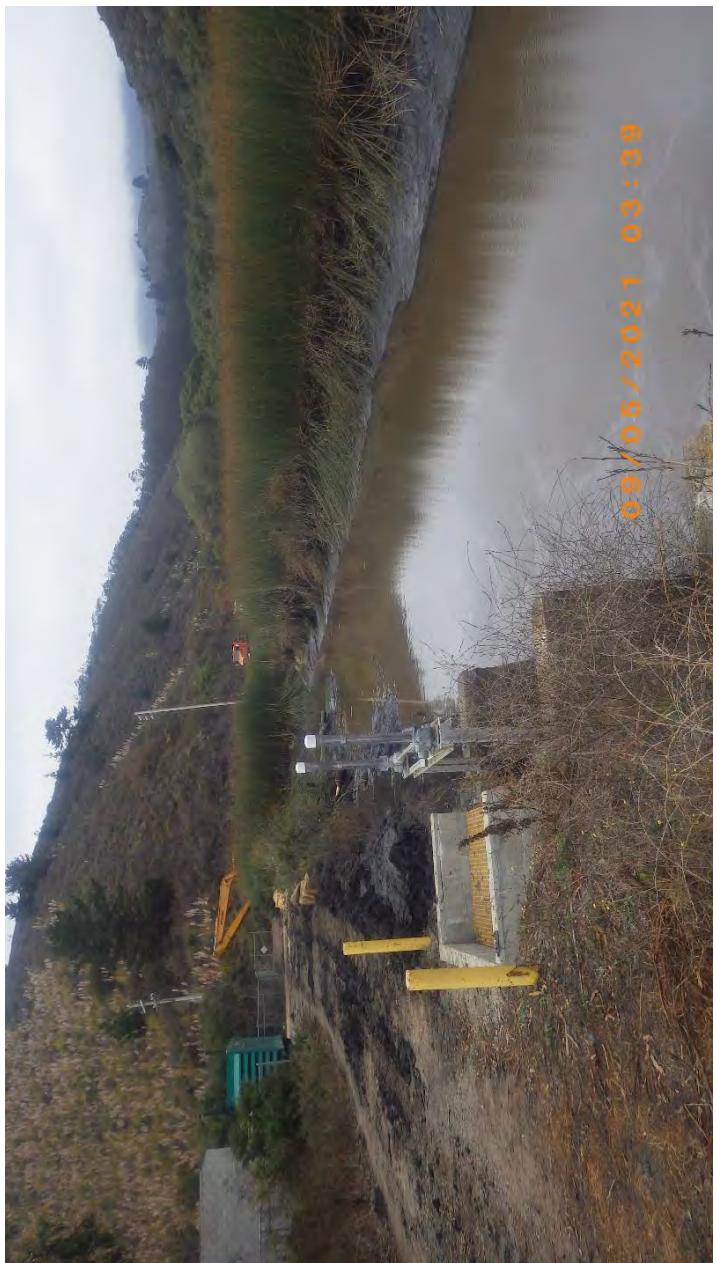
Face of dam immediately after dredging complete. Correct time stamp 10/05/2021

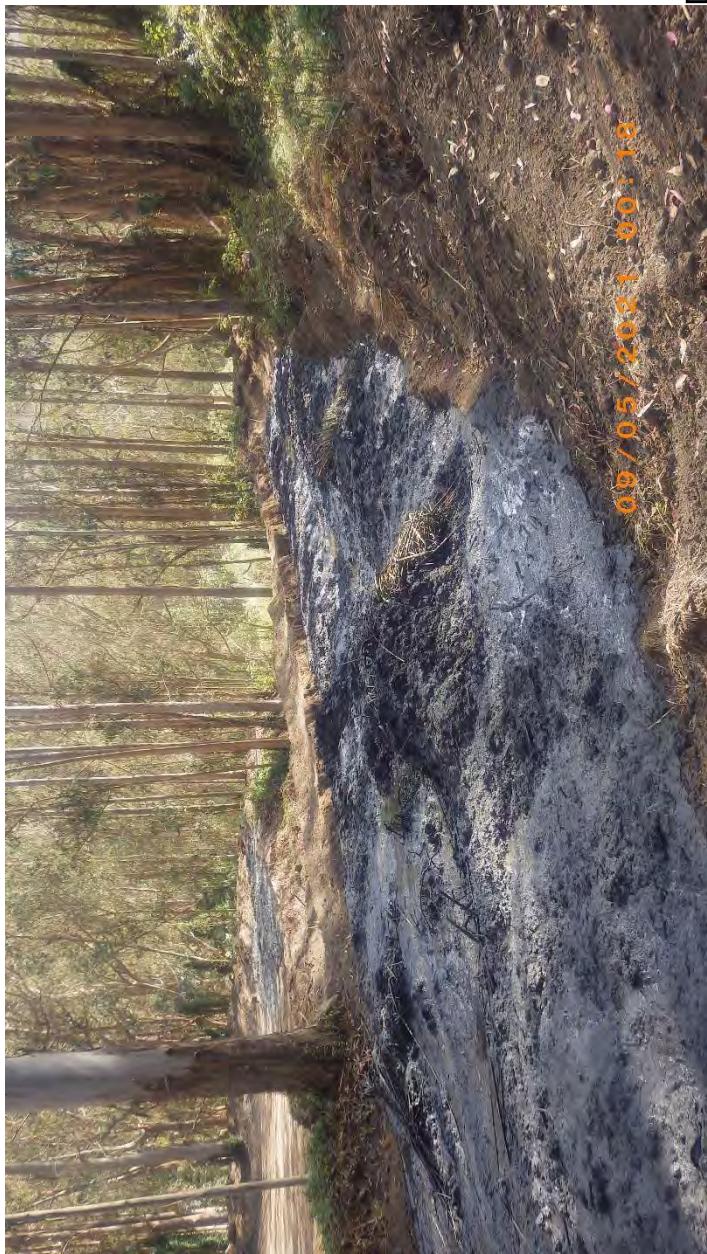
Dump site $\frac{1}{2}$ mile up watershed is a temporary holding facility while materials dry out. 10/05/2021

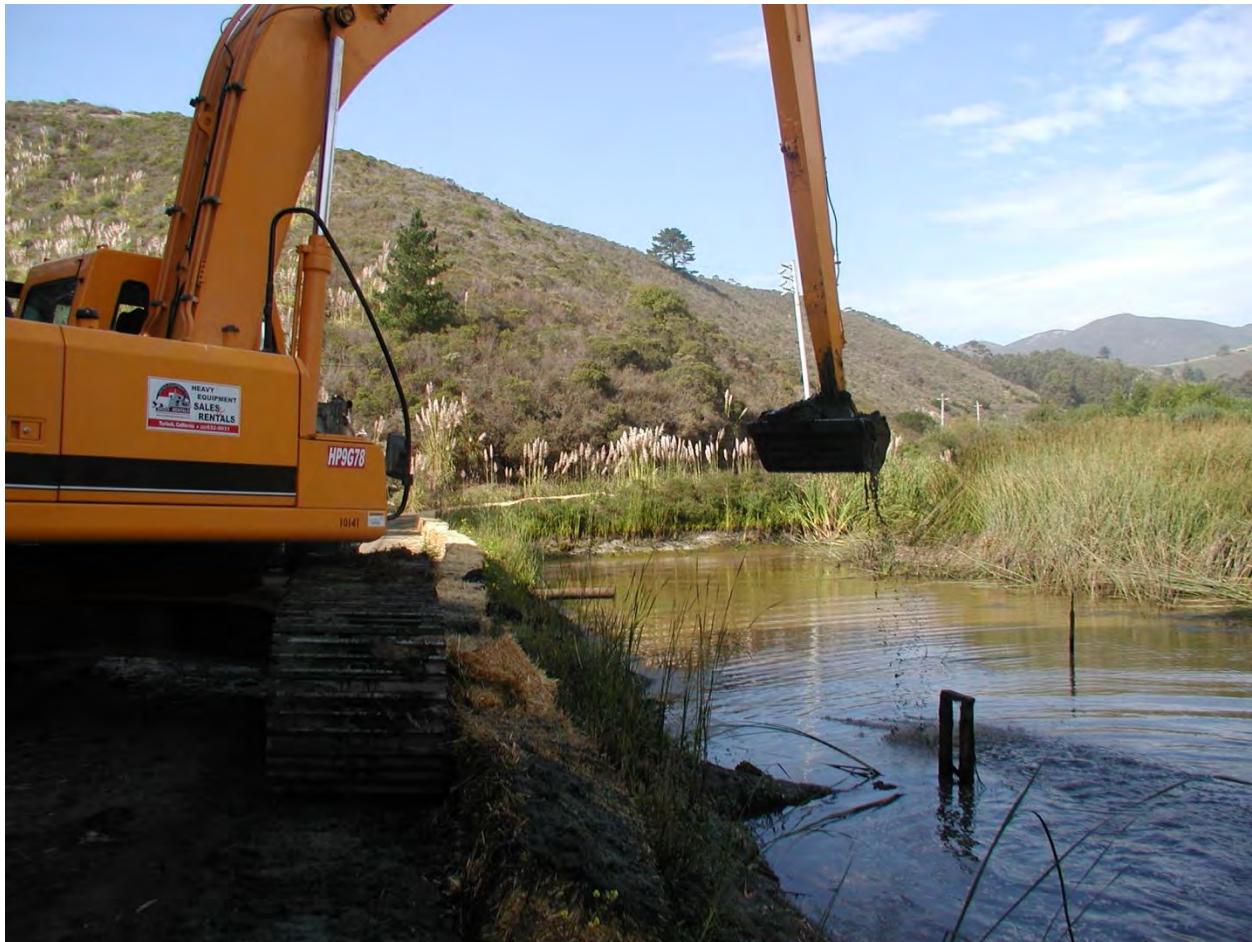
Hay bales are in place. Area around intakes is cleared.

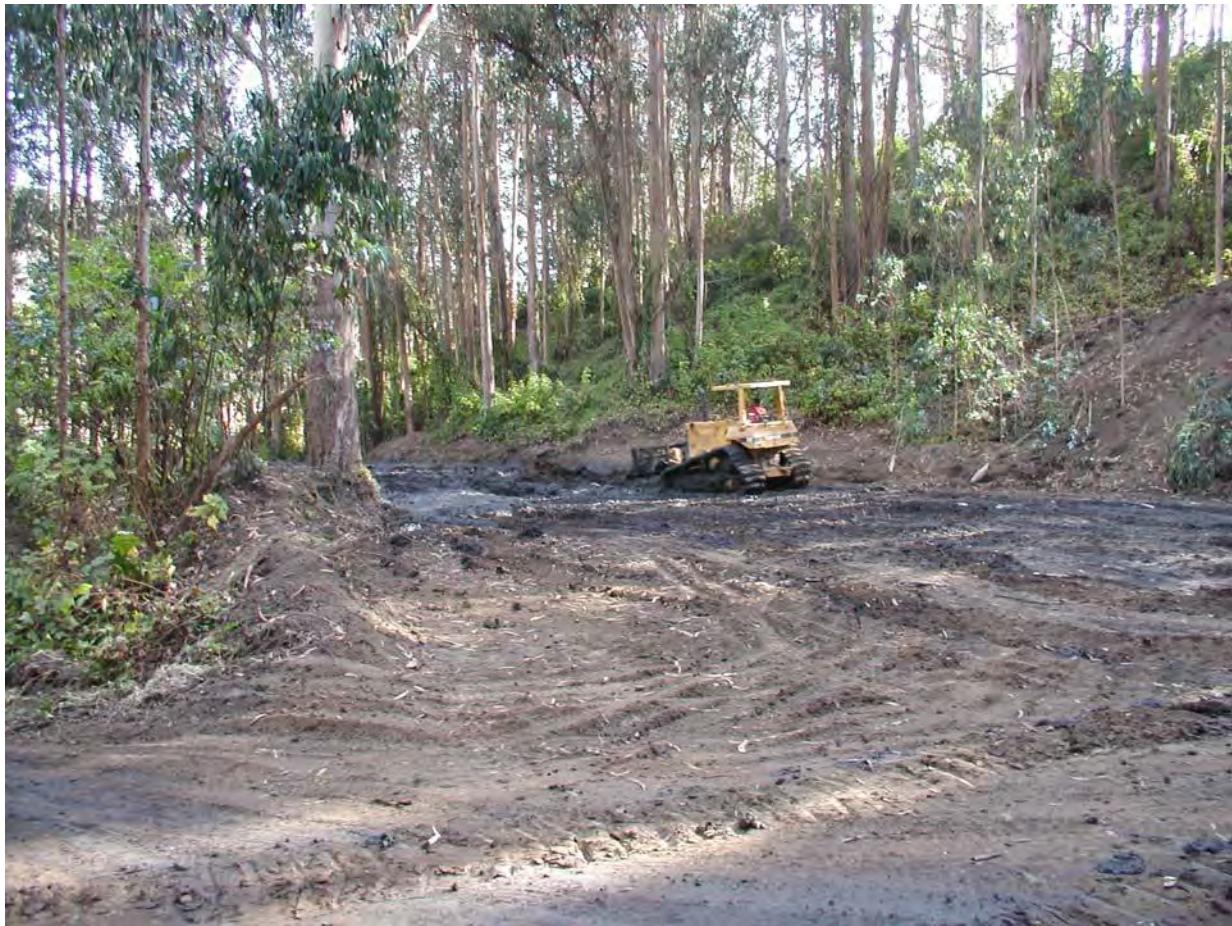
Spoils site is maintained by concentrating sediment and has containment berm.
