То:	Coastside County Water District Board of Directors			
From:	Mary Rogren, General Manager			
Agenda:	June 11, 2024			
Report Date:	June 7, 2024			
Agenda Title:	Pilarcitos Dam and Reservoir Improvements Project: Project Status – Presentation by San Francisco Public Utilities Commission

#### Pilarcitos Dam and Reservoir Improvements Project

# **Project Status**

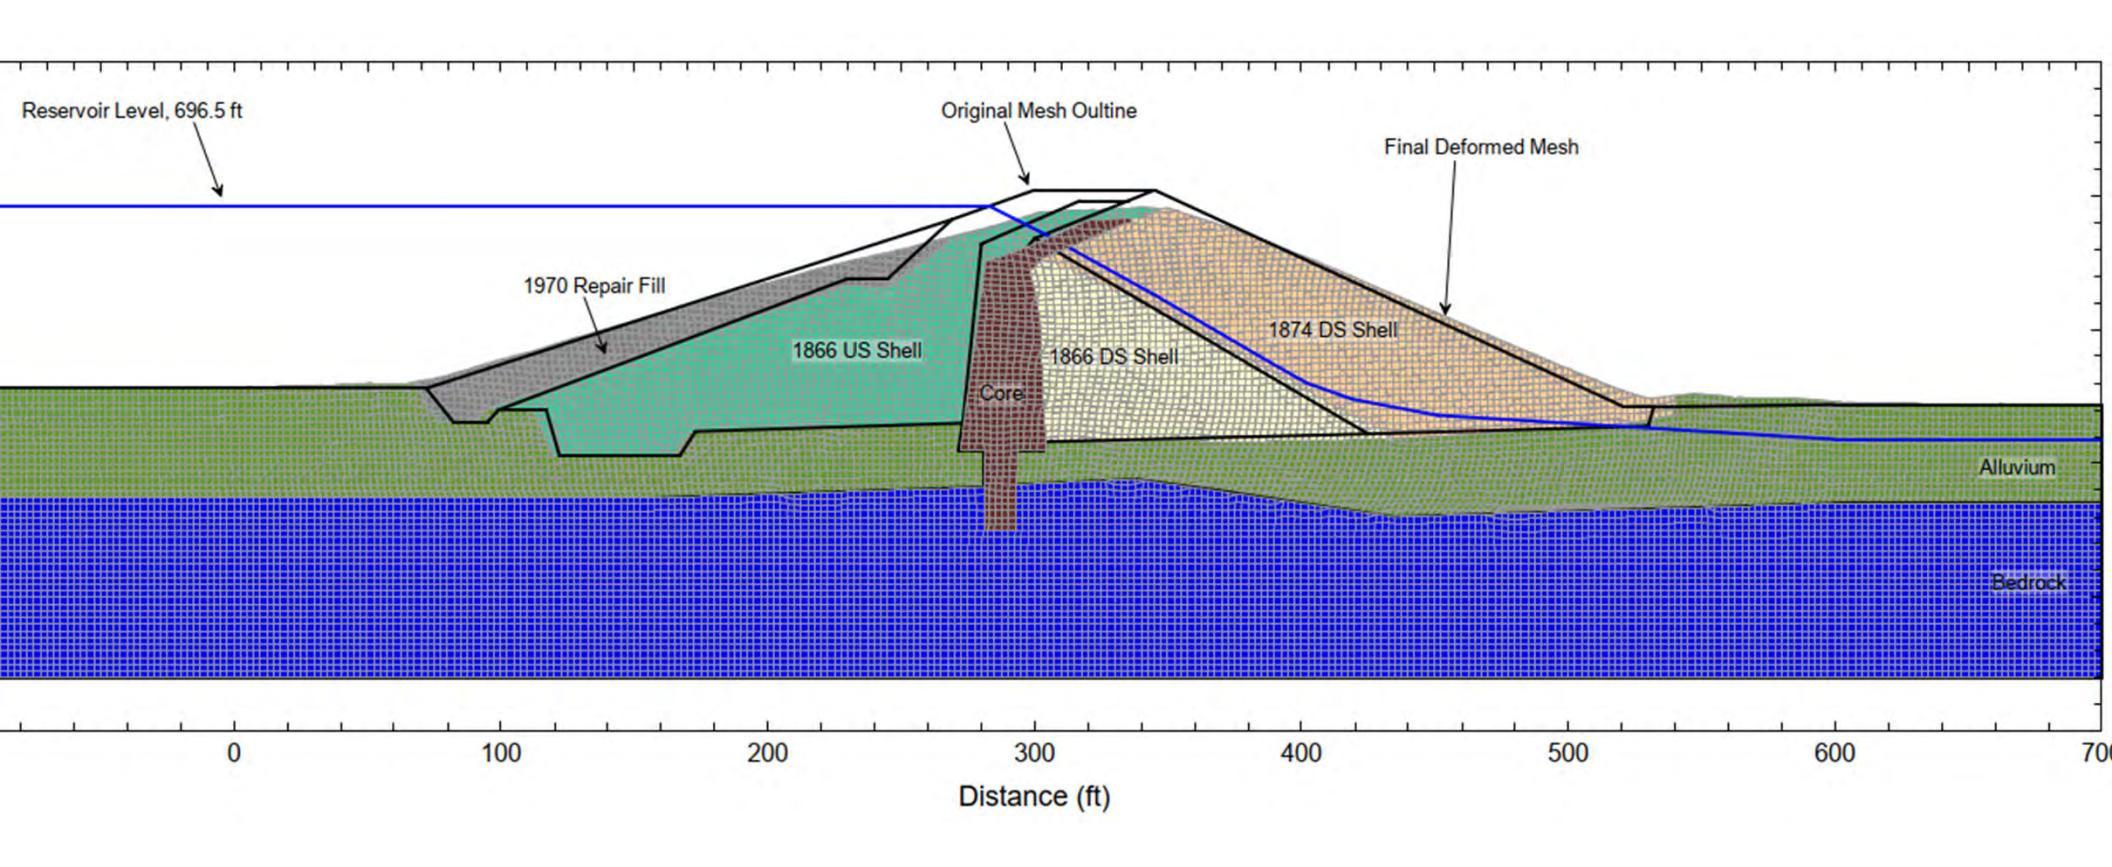
#### Embankment Section Under Seismic Loading

- Embankment Requirement Safe and Reliable Performance under static, and other extreme (seismic and PMF) loading conditions
  - Embankment does not satisfy seismic stability requirements
- Outlet Works Requirement Safe and Reliable Performance under static and seismic loading condition and reservoir draw down
  - Forebay Tower can draw down reservoir in accordance with requirements but is not safe and reliable under seismic loading
- Spillway Requirement Safe and Reliable Performance under static and other extreme (seismic and PMF) loading conditions; Safely Pass PMF flows without dam overtopping and minimum residual freeboard of 1.5 feet without excessive erosion downstream
  - Inadequate capacity to pass PMF flows and inadequate seismic resilience

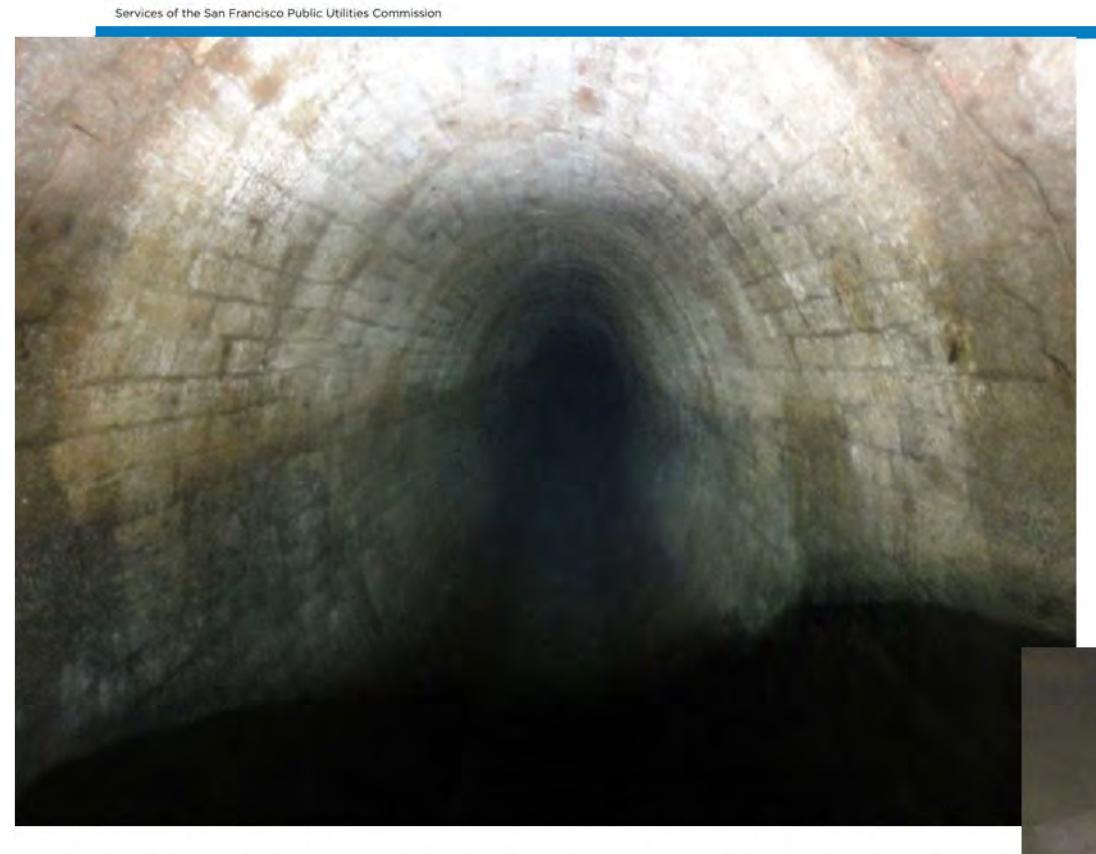
Pilarcitos Outlet Works – Tunnel No. 1

View of the Pilarcitos Tunnel No. 1 looking upstream from the outlet portal. Note the efflorescence on the walls

# Crack along the left wall of the tunnel with a ½-inch offset

Crack C5

(Note the offset of the tunnel wall.)

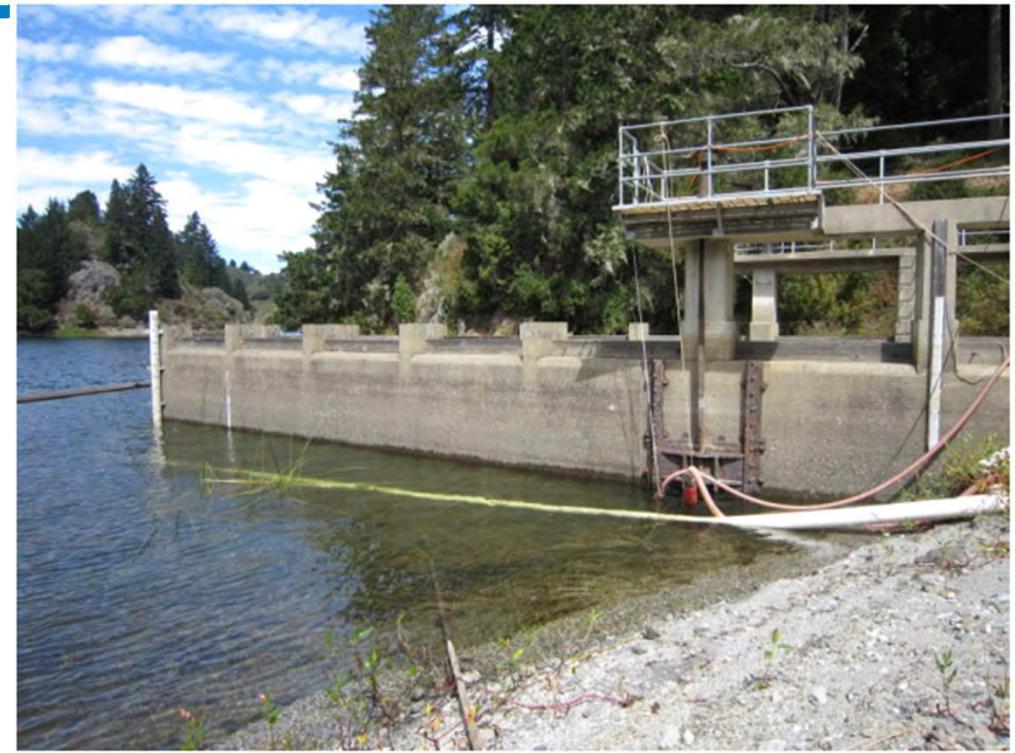
View of the bathtub weir intake structure from the boat ramp

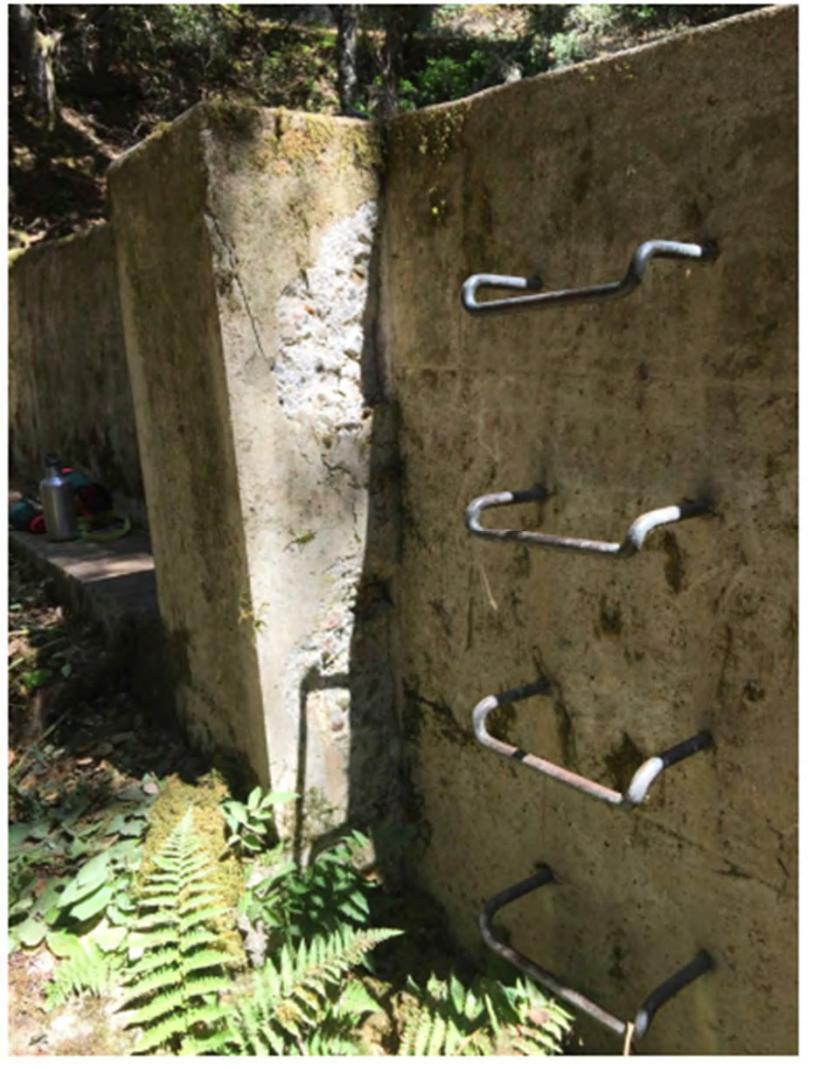
Concrete spalls on the right concrete wall of the spillway chute.

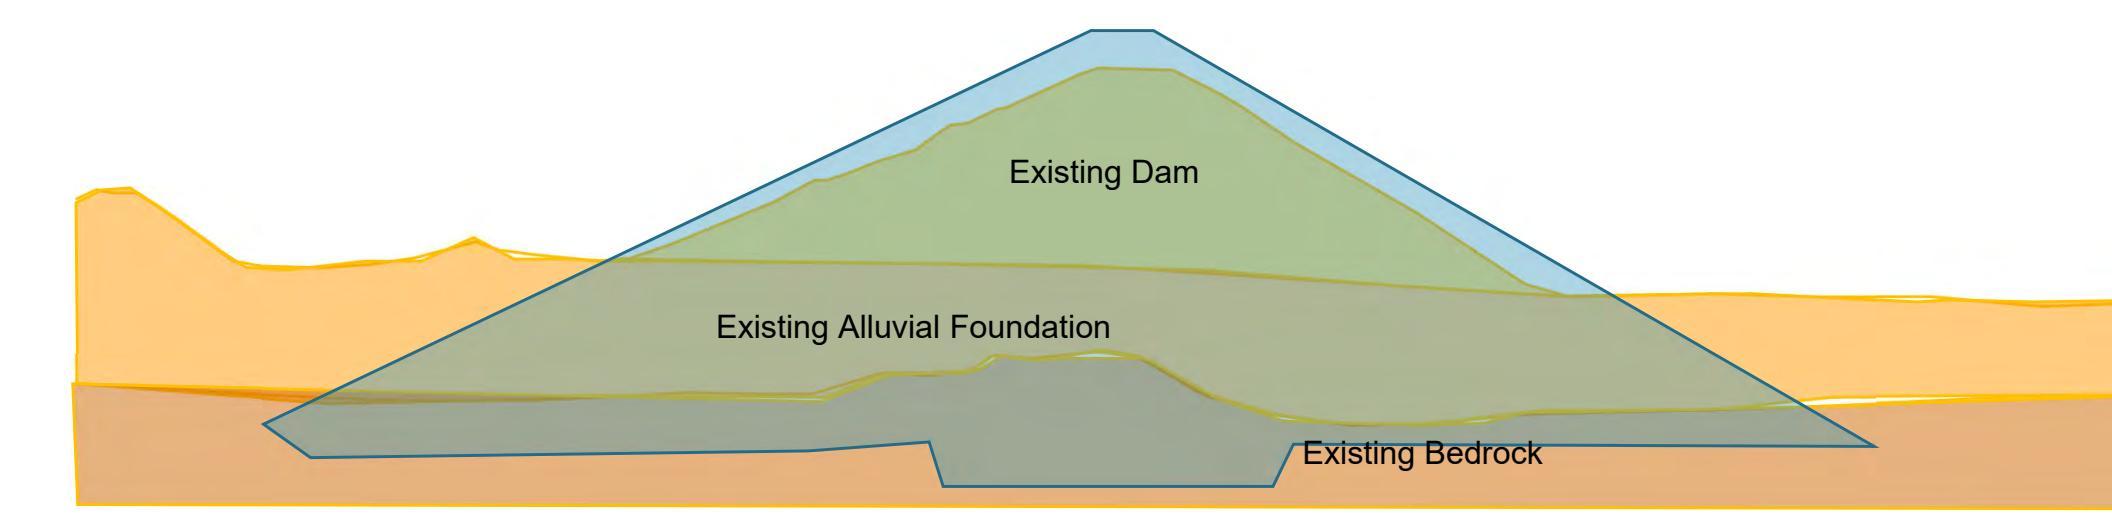
Alternative 1: New Dam, New Spillway, New Outlet Works through Dam Abutment, and Retrofit of Forebay and Tunnel No.1

- Remove existing embankment
- Excavate to competent foundation
- Construct New embankment
- Increased embankment height for additional freeboard (no increase in reservoir storage)

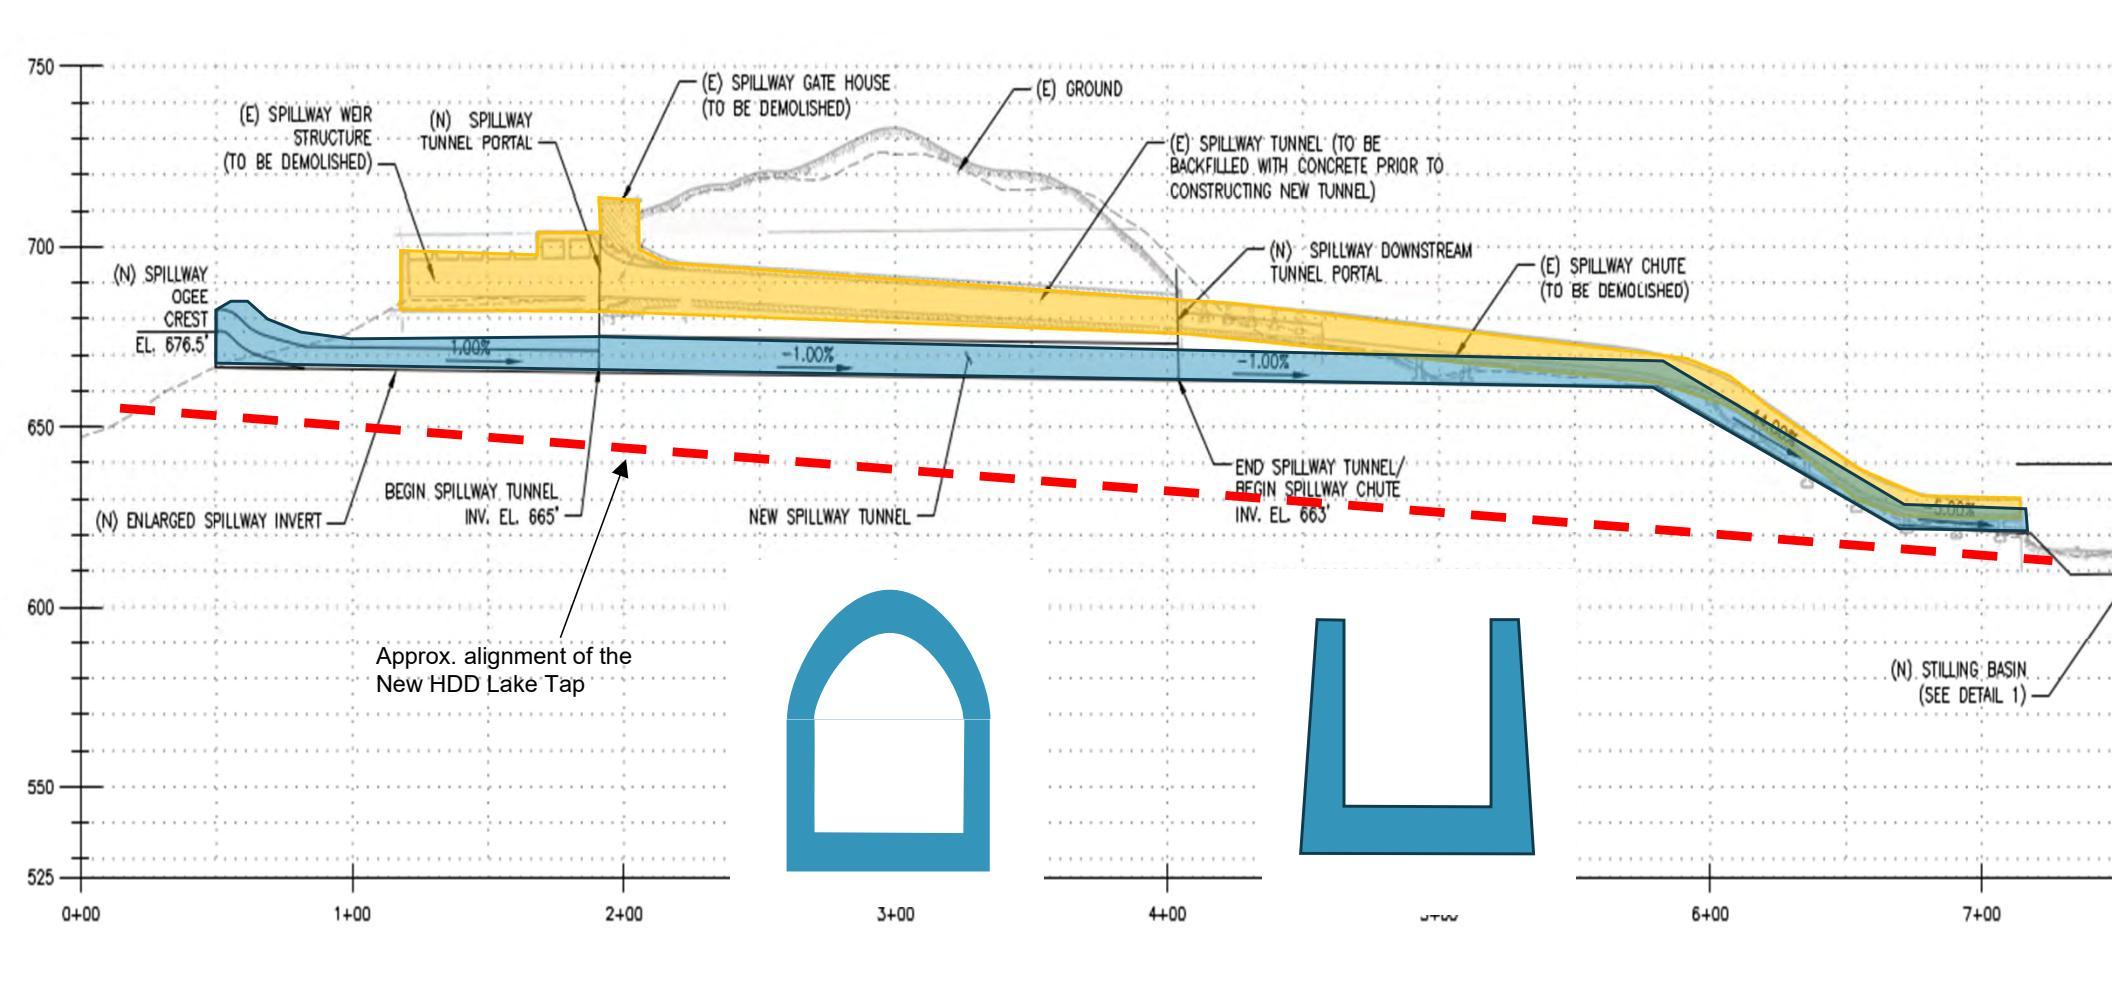
Alternative 5: Permanent Reservoir Restriction, Spillway Enlargement, New Lake Tap, and Retrofit of Forebay and Tunnel No. 1

- No updates to the existing embankment
- Permanent reservoir restriction (lower water level by ~15'- 20')
- New Enlarged Spillway with lowered crest El. (696.5' to 681.5' or 676.5')
- New Horizontal Directional Drilled (HDD) Lake Tap for operational releases (Inv. El. 650')
  - Reduced reservoir storage but can provide existing operable storage due to Lake Tap
